ARTIFACT IDENTIFICATION AND ASSESSMENT
PLUM BROOK REACTOR FACILITY
SANDUSKY, OHIO

Patrick W. O'Bannon, Ph.D.
Gray & Pape, Inc.
1318 Main Street
Cincinnati, OH 45220

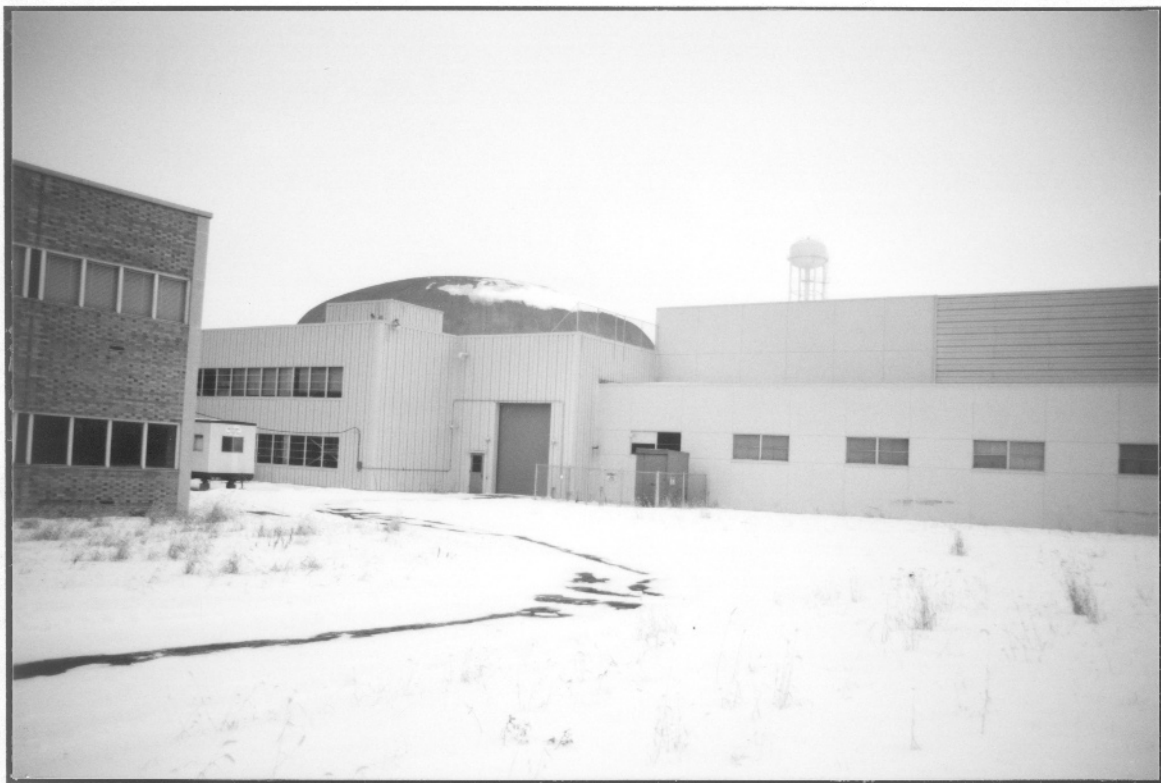
Plate 1. View of Reactor Building and Hot Laboratory Building to northeast.

The Reactor Building is a 4-story, flat roofed, building measuring approximately 150 by 160 feet (see Figures 3 and 4, Plate 1). The Reactor Building houses the reactor and its containment vessel and provides setup and work space around the containment tank at grade level (Plate 2). The building also housed shop and personnel facilities and control panels for experiments. The reactor control room is located on a mezzanine that extends along the north and west walls (Lewis Research Center Staff 1959: 15).

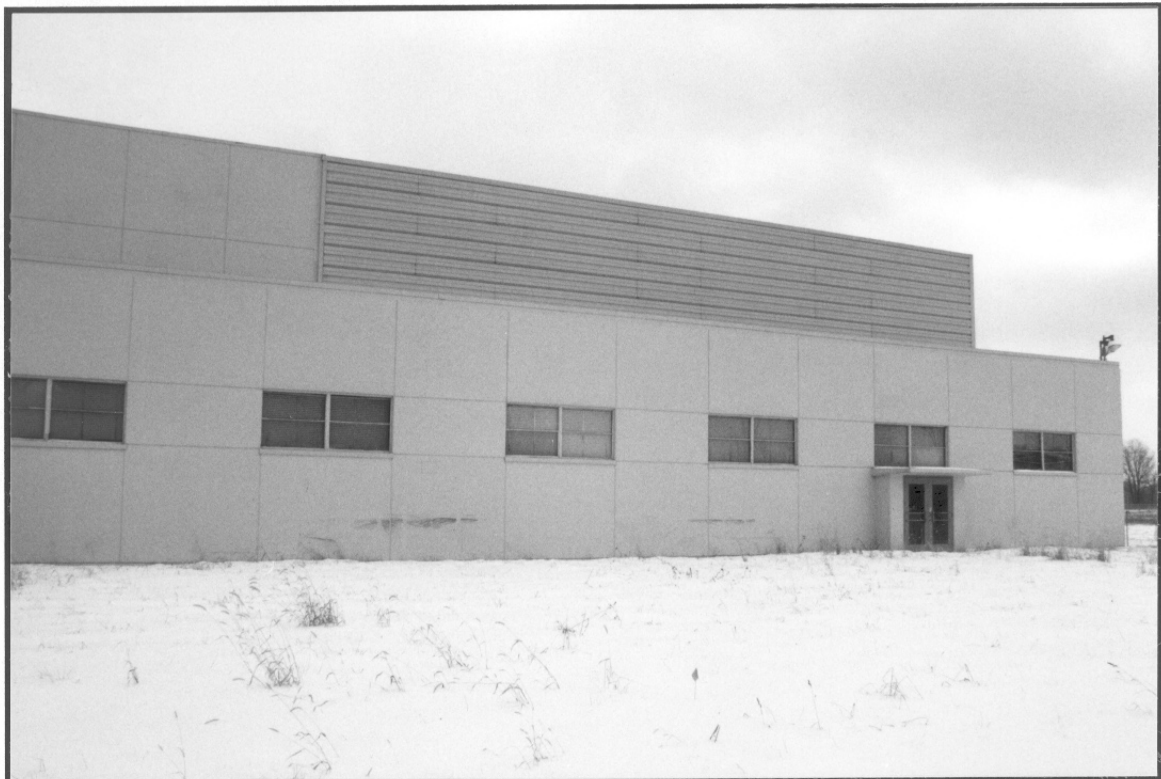
Plate 3. View of Hot Laboratory Building to southeast.

The Hot Laboratory is a 2-story concrete building, measuring approximately 104 by 136 feet, attached to the south façade of the Reactor Building (see Figure 6, Plate 3). Immediately adjacent to the Reactor Building is a 40- by 75-foot hot handling room with 72-inch thick concrete walls. This room served as a radiation shield and air lock for most Hot Laboratory operations. The canal from the Reactor Building passes through this

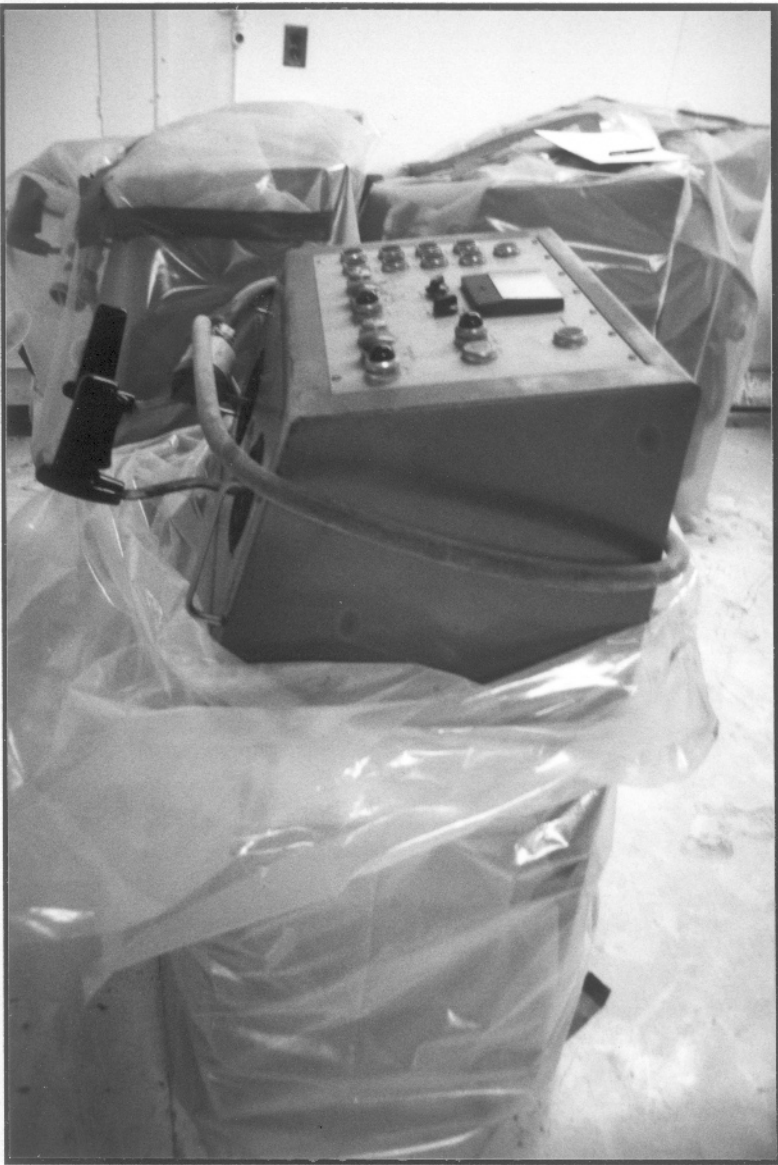
Plate 7. Manipulator control consoles in storage in Manipulator Repair Shop.

Other extant equipment in the Hot Laboratory includes a series of Manipulator Control Consoles (Model 302-E) manufactured by General Mills, Inc., in Minneapolis. These units are presently stored in the Manipulator Repair Shop (Plate 7). They were originally used to operate the General Mills Manipulators in two of the Hot Cells.

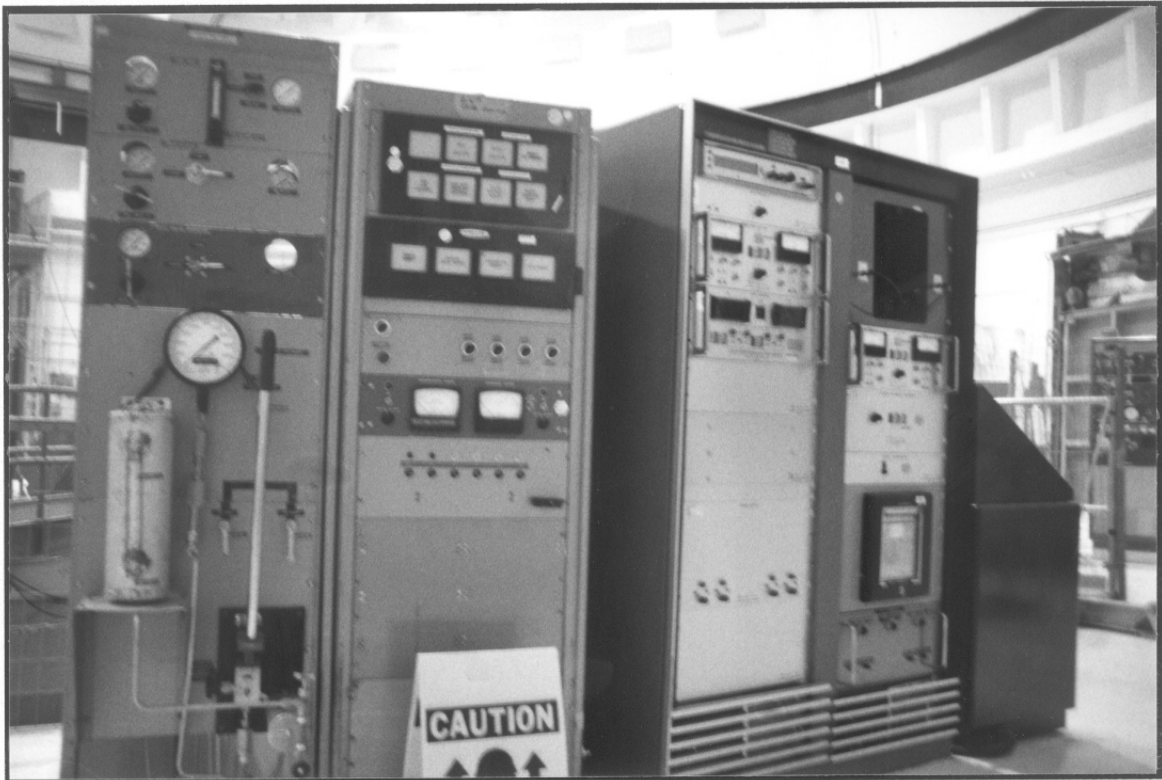
Extant artifacts within the containment vessel include electronics used to monitor the reactor and experiments (Plate 9). None of this equipment appears to be unique to the PBRF. Additional equipment used to insert experiments into the reactor is contaminated and does not appear suitable for preservation (Plate 10).

Plate 9. Monitoring equipment inside Containment Vessel.

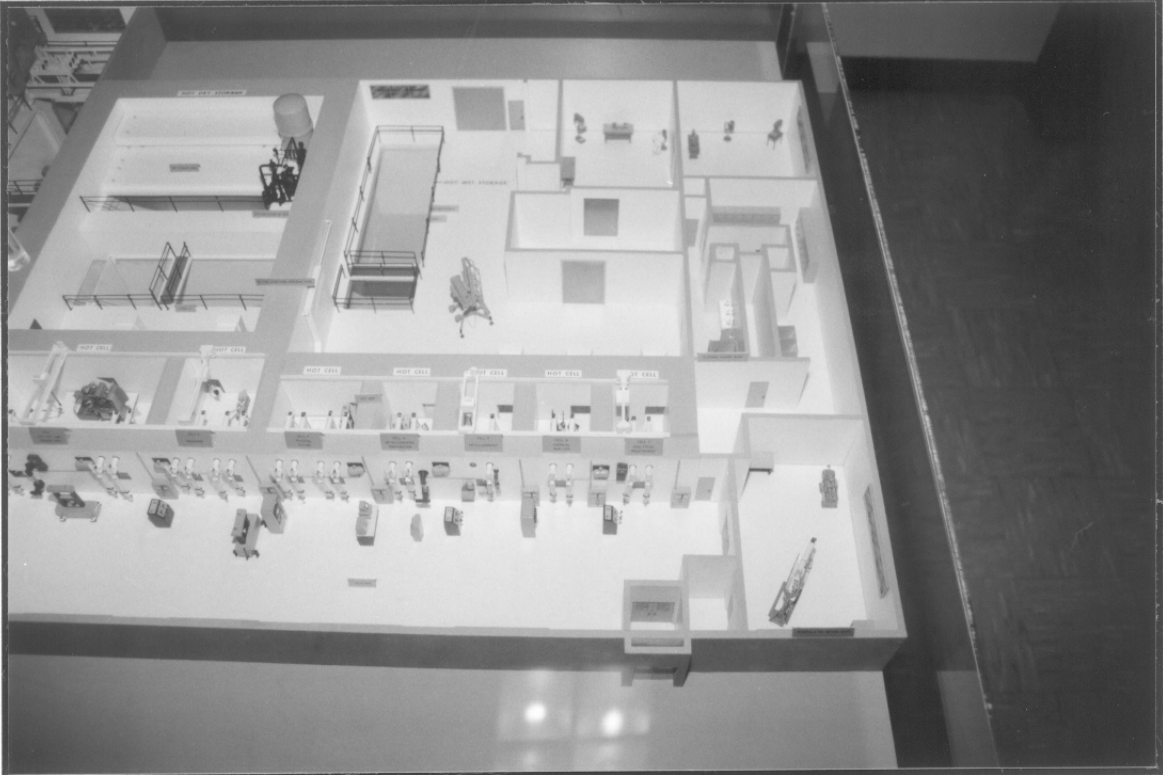
Perhaps the most significant artifact associated with the PBRF is a large, scale model of the facility currently on display in the cafeteria at Plum Brook Station (Plate 19). This model depicts the Reactor Building (Plate 20) and the Hot Laboratory (Plate 21) in considerable detail. For the lay audience, the model is probably better at conveying the design and physical organization and operation of the PBRF than photographs or drawings. The model is clearly labeled and is readily interpreted. Features and elements that are partially hidden or difficult to view in photographs are clearly depicted (Plates 22, 23, and 24).

Plate 21. View of Hot Laboratory portion of Reactor Model.

The principal artifact recommended for preservation is the large scale model of the PBRF presently on display in the Plum Brook Station cafeteria. This model offers the greatest opportunity for interpreting the history, operations, and significance of the PBRF. Other artifacts recommended for preservation include the Main Control Panel, the Remote Monitoring Panel, and the Reactor Water Systems Panel, all located in the Main Control on the mezzanine of the Reactor Building. The mass spectrometer and its controls, located in Room 213A of the Office and Laboratory Building, while not uniquely related to the operation of the PBRF, is nevertheless a significant piece of scientific equipment and likely worthy of preservation. There are a variety of small scale elements, including the “REACTOR ON” signs, that could be easily preserved. The “RIF” blackboard in the Office and Laboratory Building is a unique artifact related to the social history of the PBRF and its closure. This artifact is also worthy of preservation.
